SUMMARY

1234 Main St. WAXHAW NC 28173

Rich Smith
InterNACHI Certified Professional Home
Inspector, NC License # 5497
Home Inspections by Rich
7043890599
rich@hibyrich.com

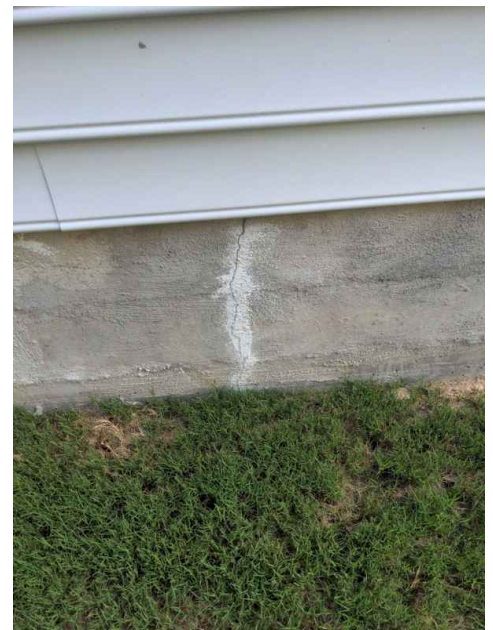
On the Left

2.1.1 Foundation

CRACK: OPEN

There is a crack in the foundation on the left side of the home. Cracks in the foundation may indicate a deficiency in the foundation that can change and worsen over time, affecting the structural integrity of the home and leading to expensive repairs. There are no current signs of movement. The crack should be monitored by the homeowner for any future changes. If the condition changes, a structural engineer should be consulted to determine the significance/cause of the cracks and to outline any necessary repairs if necessary. If the engineer recommends repairs, only a licensed general contractor, specializing in foundation repair, should be consulted to make the repairs.

Recommend monitoring.

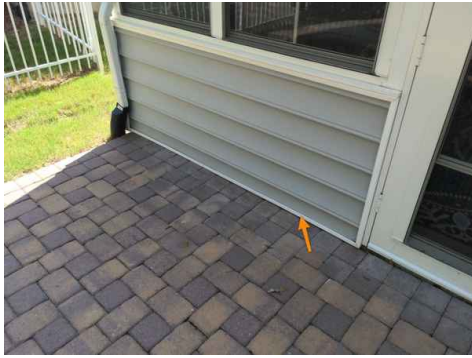
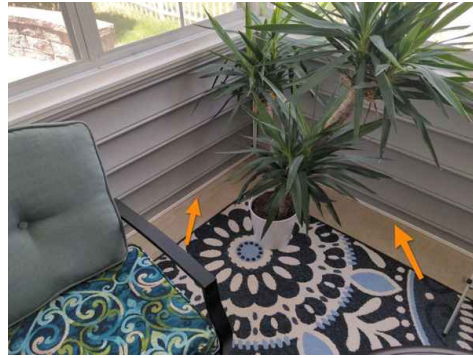
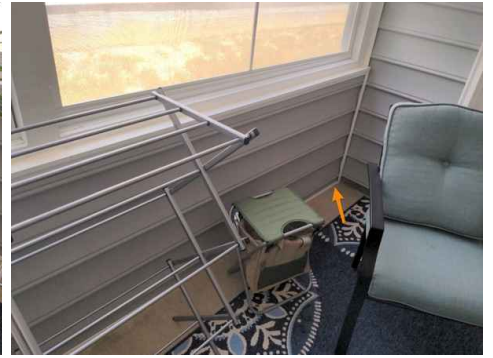
Rear

3.1.1 Siding & Trim

SIDING: GAP NOT LARGE ENOUGH

There was not a large enough gap between the siding materials and horizontal surfaces on the rear of the home inside and out side of the screen room. The lack of an adequate gap prevents inspection of the correct installation of any required flashing and may contribute to premature deterioration of the siding. A licensed siding contractor should be consulted to evaluate the gaps and to repair as necessary.

Contact a qualified siding specialist.

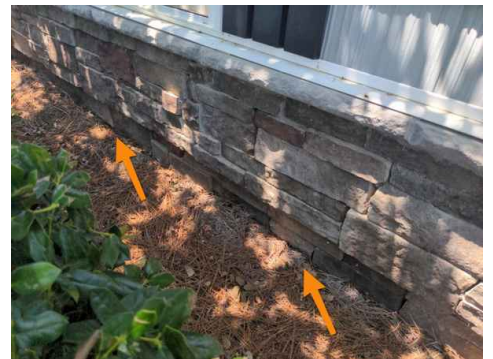
FRONT

3.1.2 Siding & Trim

STONE VENEER: NO GAP AT GROUND

The stone veneer siding on the front of the home reaches to the ground level. This prevents inspection of the foundation for cracks and termite activity and may allow moisture to wick up behind the veneer. This installation is not in compliance with the installation guidelines provided by the Masonry Veneer Manufacturer's Association (MVMA). The installation guidelines are available [here](#). Stone veneer siding should stop before the ground so that there is at least a 4" gap between the siding and the ground. A licensed general contractor should be consulted to evaluate this installation and to recommend repairs as necessary.

A licensed siding contractor should be consulted to ensure the stone veneer is in compliance with the installation guidelines provided by the Masonry Veneer Manufacturer's Association (MVMA). The installation guideline are available [here](#).

Contact a qualified siding specialist.

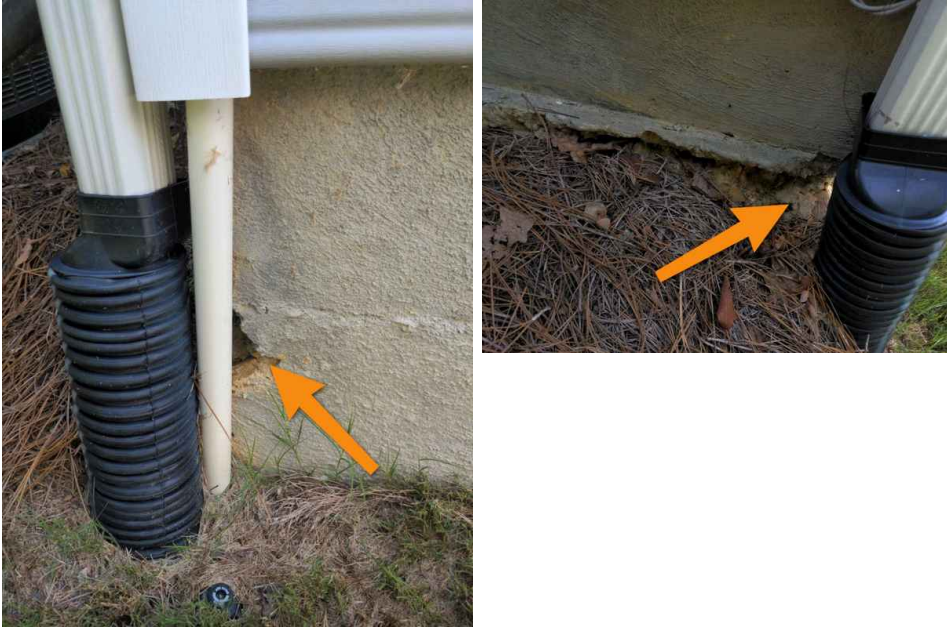
REAR LEFT CORNER

3.8.1 Vegetation, Grading, Drainage, Retaining Walls

SOIL: EROSION

There is soil erosion on the rear left corner of the home where rain water is clearly accumulating and removing soil and ground cover. This will continue unless addressed by a landscaping specialist. The concern is that the erosion will cause water to move in ways unintended and possibly cause damage to the foundation of the home.

Contact a qualified landscaping contractor

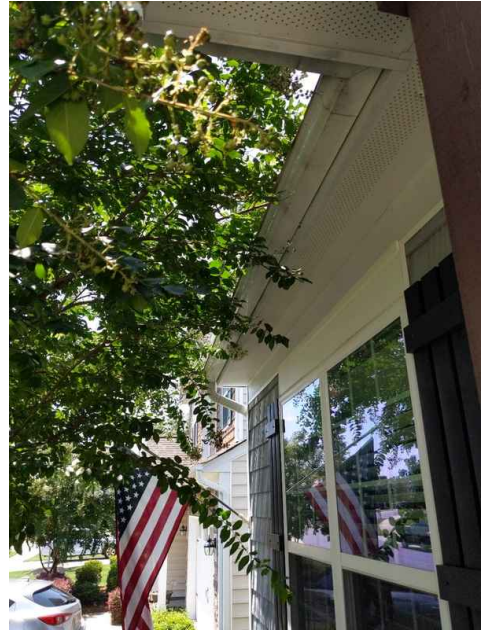
FRONT

3.8.2 Vegetation, Grading, Drainage, Retaining Walls **TREE: OVERHANG, POSSIBLE DAMAGE**

There are trees overhanging the roof on the front of the home. This can cause damage should branches fall, and will contribute to debris on the roof and in the gutters. A tree service should be consulted to evaluate the trees and trim as necessary.

Contact a qualified tree service company.

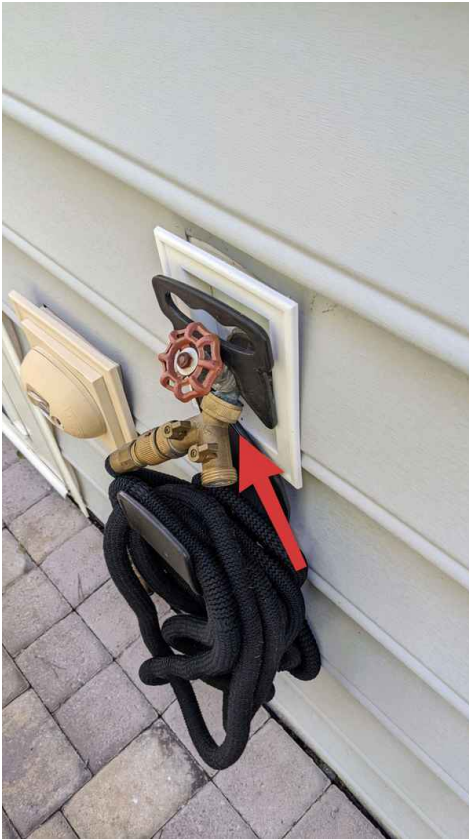
REAR OF THE HOME

5.4.1 Exterior Fixtures / Faucets

HOSE BIBB: NO VACUUM BREAKER

I did not find anti-siphon vacuum breaker on the hose bibb at the rear exterior of the home. The vacuum breaker is designed to prevent the backflow of contaminated water from an attached hose into the potable water system. There are simple, inexpensive vacuum breaker attachments for hose bibbs. A licensed plumber should be consulted to install vacuum breakers all hose bibbs that are not currently protected with vacuum breakers.

Contact a qualified plumbing contractor.

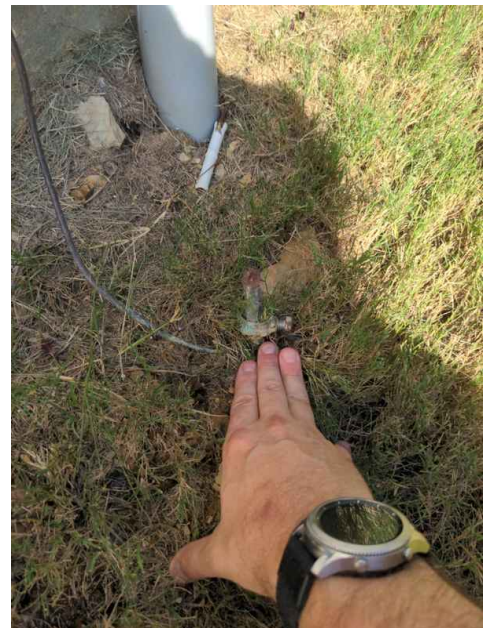
RIGHT SIDE

6.2.1 Main Panel

DRIVEN ROD: NOT BURIED

The driven rod on the service entrance which is located on the right side of the home is not completely buried. The home's electrical system is grounded to this rod and has installation requirements that may not have been met which ensure the proper function of the overcurrent protection and limit safety hazards that could cause serious personal injury. The rods are designed to be mostly buried in the soil and the driven rod at this home is sticking significantly out of the ground. A licensed electrician should be consulted to evaluate and repair.

Contact a qualified electrical contractor.

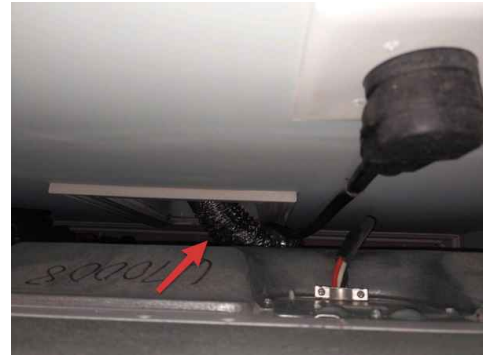
BEHIND THE DRYER

11.5.1 Dryer

DUCT: NOT METAL

Fire Hazard: the dryer exhaust behind the dryer does not use metal duct conforming to UL 2158A, an Underwriters Laboratory standard that is designed to prevent fires in dryer duct. The plastic/foil duct used in this home will trap lint much more easily than metal duct and is prone to collapsing behind the dryer, impeding air flow and increasing heat in the collapsed areas. Heat from the dryer exhaust can ignite lint that accumulates in the duct, and a fire in the duct will burn through plastic/foil duct. Metal ducts do not trap lint as readily and are much more resistant to burning and collapsing. A licensed general contractor should be consulted to replace the current dryer duct with rigid metal or semi-rigid metal duct conforming to UL 2158A and the entire dryer duct should be cleaned of lint annually.

Contact a qualified appliance repair professional.
